Identification of changes in the microstructure of damaged elements spherical joint

Mr. Sc. Mujanović Enes¹, Dr. Sc. Denijal Sprečić²

^{1,2} University of Tuzla, Faculty of Mechanical Engineering, Univerzitetska Str. 4, 75000 Tuzla, Bosnia and Herzegovina

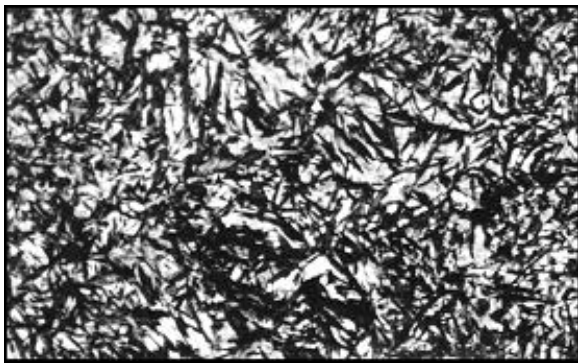
The analyses of the microstructure were carried out on the optical microscope. The microstructures appeared after the corrosion of the sample in the reagent 1% HNO₃ in ethyl alcohol, and the observation was carried out at the magnification X 625. The analysis was carried out on the necks of the cross axle and on the sleeves of the needle bearings. The picture of the microstructure of the cross-section of the neck is given in the Fig. 2 and from the analysis of the photographic picture it is possible to see martensite + residual austenite which is not desirable in the cemented layer because of its lower hardness. This indicates that the thermal treatment was not performed well. Most probably the sample was heated to a higher temperature during its tempering than it is allowable for this quality of treated steel which resulted in the increase of the austenite grain so that a certain quantity of austenite was retained between the martensite needles during the cooling.

Figure 2: Neck sample; cross section; cemented layer, martensite + residual austenite

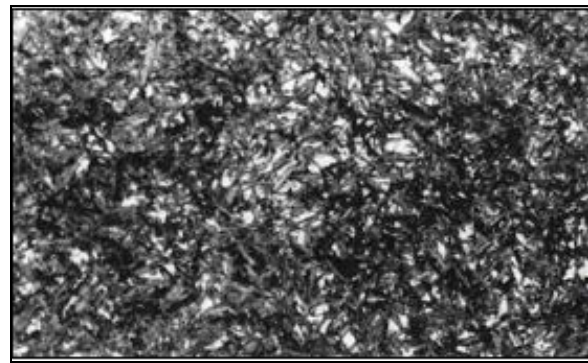
Figure 3: Neck sample; longitudinal section; cemented, layer; martensite + residual austenite

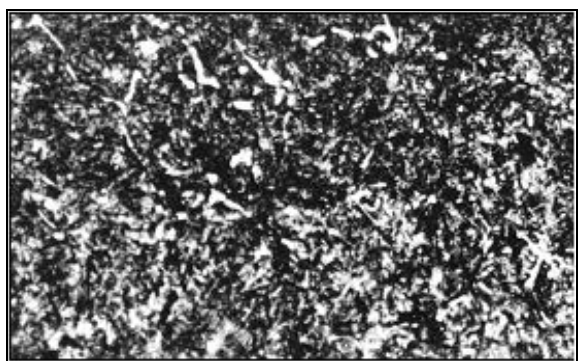
The picture of the microstructure of the longitudinal section of the sleeve is given in the Fig. 3, and from the analysis of the photographic picture it can be seen that in the microstructure of the sleeve the cementite is present on the grain border in the cemented layer in addition to martensite and the residual austenite. This phenomenon in the structure occurs at higher temperatures of cementing by means of carbonizing. These temperatures are not appropriate for the quality of the given steel in which case higher carbon content on the surface is achieved. This results in the separation of cementite on the borders of grains. In parallel to the appearance of cementite the grain increases too, which, in turn, increases the brittleness of the cemented layer.

Figure 4: Sleeve sample; cemented layer on the outer edge; martensite + residual austenite + cementite

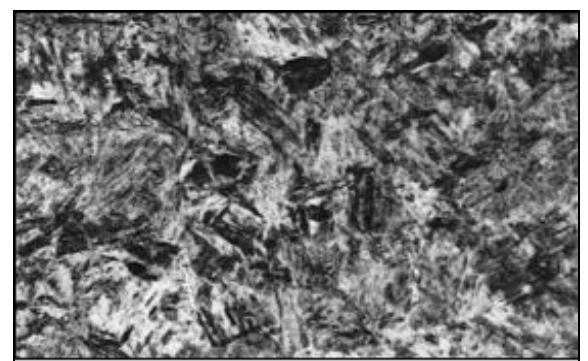
Figure 5: Sleeve sample; transit point between the cemented layer and the core
