## Procedure for Technical Analysis of the Cause of Volvo FH 12 Road-Train Trailer Gearbox Failure

Ján Mandelík<sup>1</sup>

<sup>1</sup>Department of Transport Safety, The University of Security Management in Kosice, Kosice, Slovak Republic  
Corresponding Author: Ján Mandelík

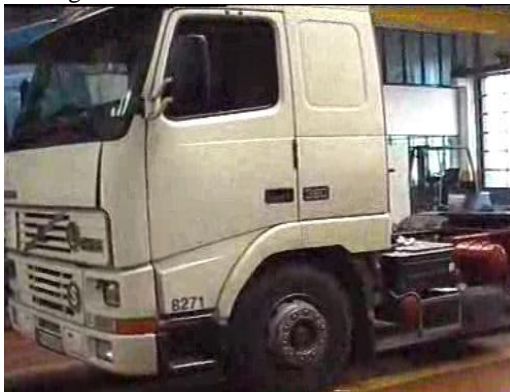
The vehicle and its engine were inspected in detail, as a result of which it was found that no incompleteness was observed – Fig. 1

Side view of Volvo FH 12 trailer

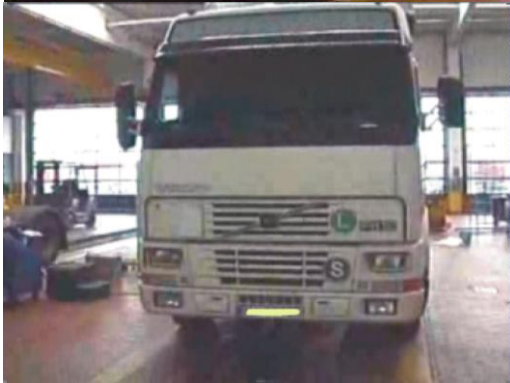
Front view of Volvo FH 12 trailer

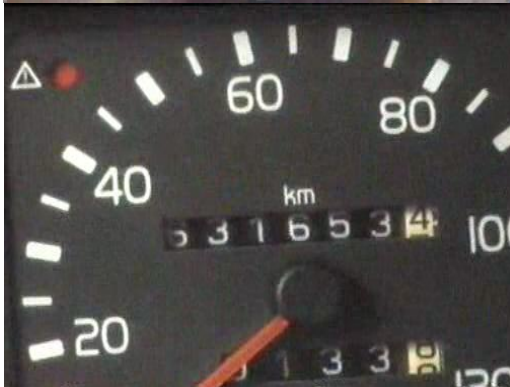
View on the vehicle's tachometer

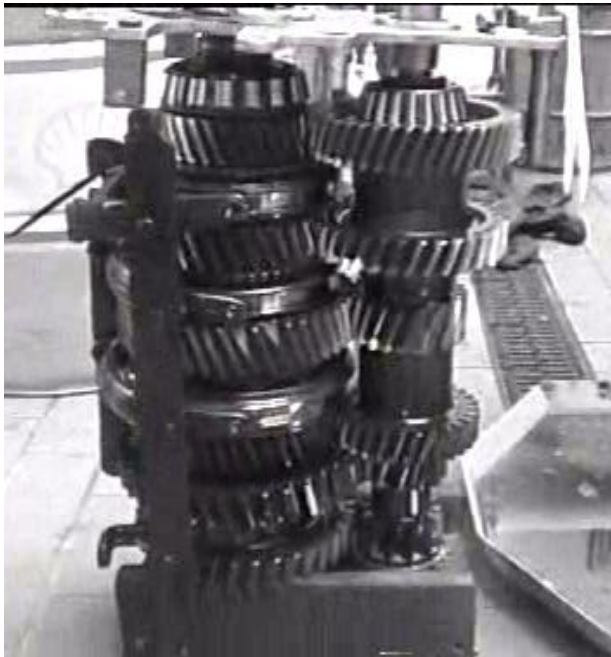
view of the spindle gear shaft after removal from the gearbox housing

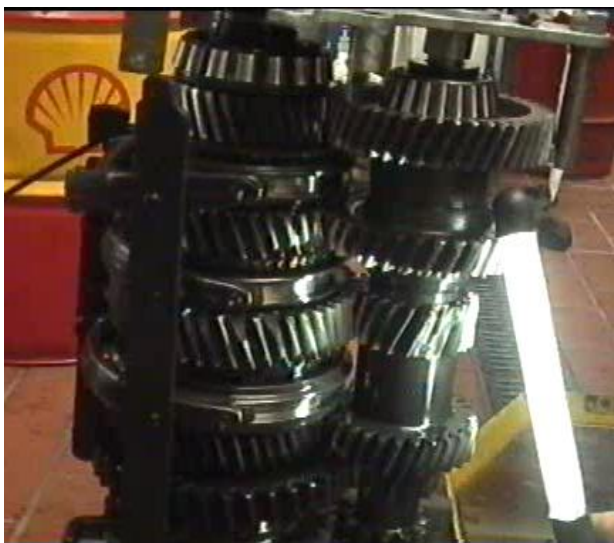
a closer look at the gear shafts with gear wheels

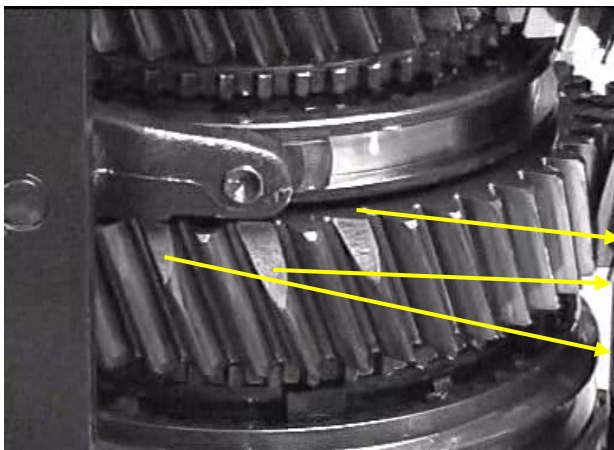
View of spline shaft gearing and marking of damages:

D1

D2

D3

- 5<sup>th</sup> stage: formation of brittle fractures D1, D2, D3  
These occurred as a consequence of tooth abruption due to subsequent impacts in the transmission of driving force in the plane of engagement line which was not smooth at any given time

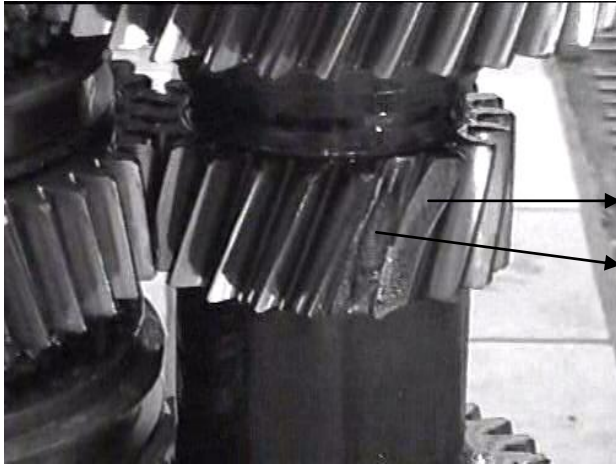
View of spindle shaft gearing and marking of damages:

P1

P2

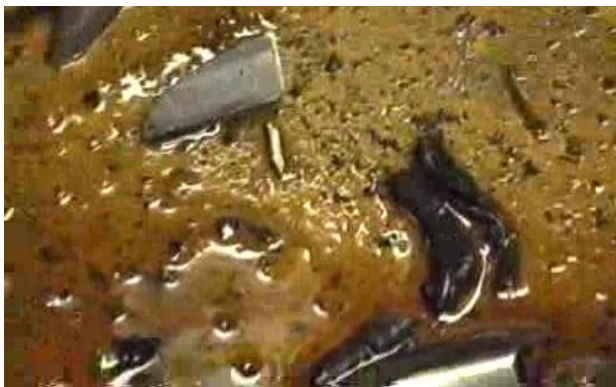
View of fragments found in the gearbox

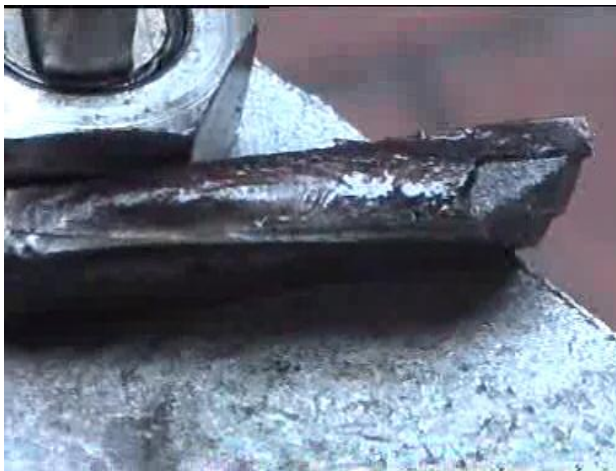
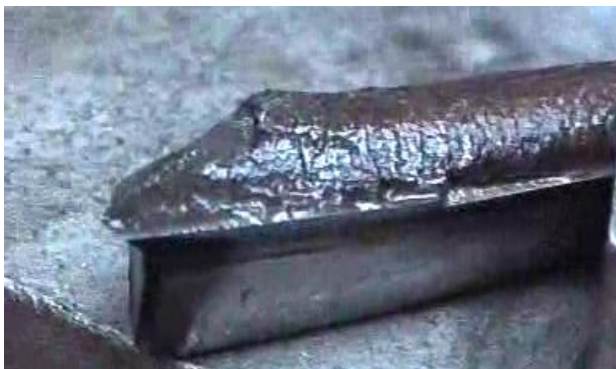
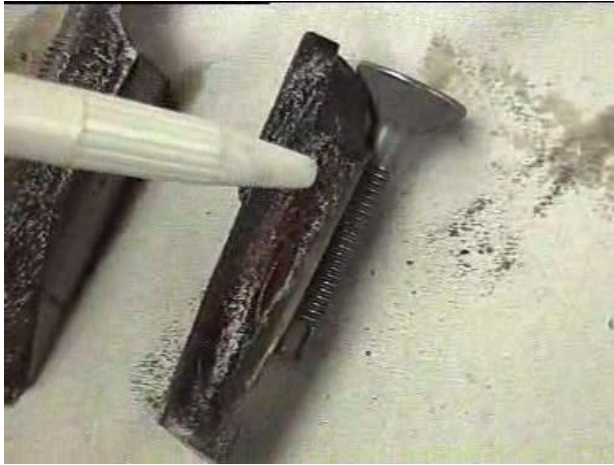
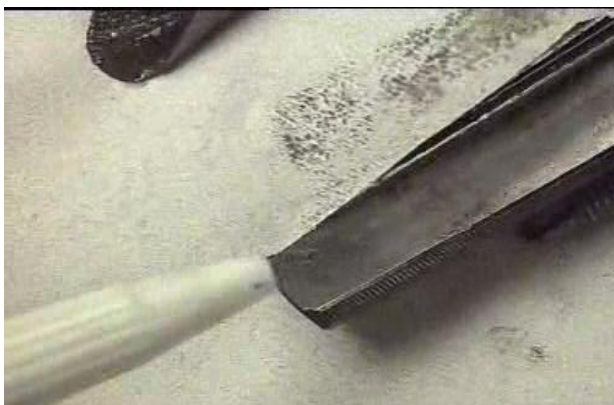
View of tooth fragments found

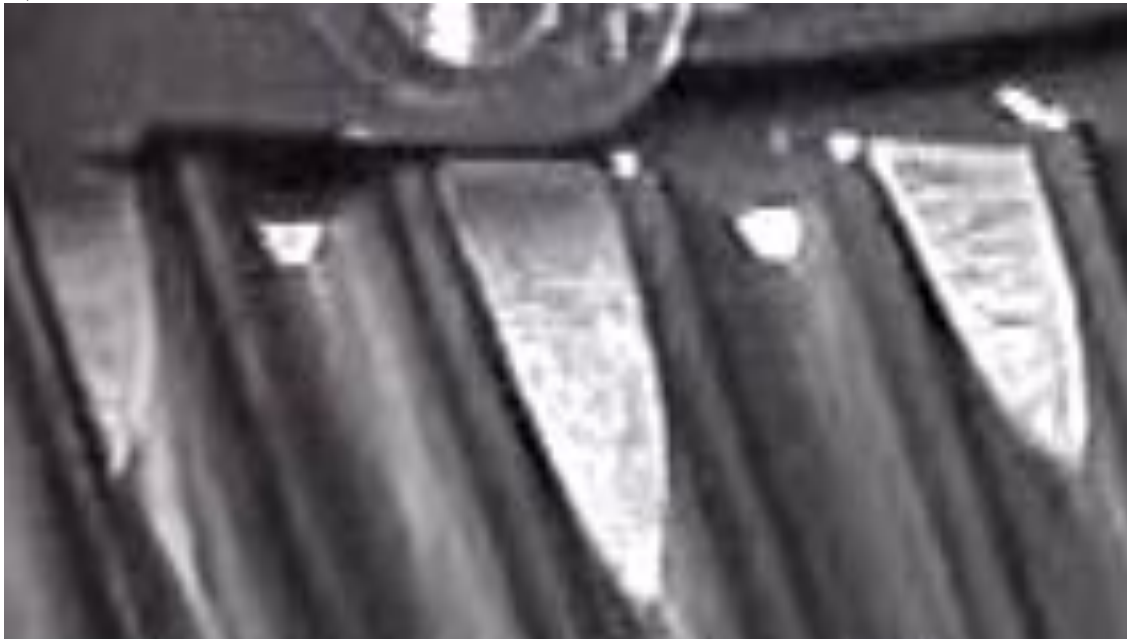
**Fig.4 View of characteristics of D1, D2, D3 fracture areas**

In that case, it is possible to draw from the characteristic features (grain size, coarse and broken surface with a clear microstructure of the material, without any marks and deformations) in the area of fracture, that it is a brittle fracture caused by a mechanical load whose size exceeded the mechanical properties of material in the profile where fracture occurred. This corresponds to the plane of rupture corresponding to the plane of greatest force stress (in direction of circumferential force in common normal plane, which is at the same time line of engagement)

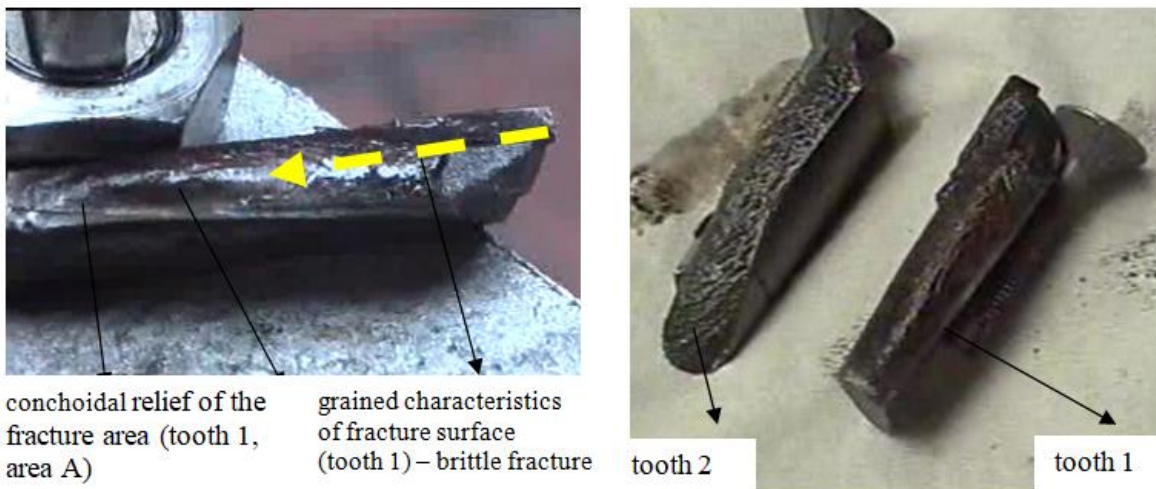
Fig. 5 View of characteristics of teeth fractures areas 1,2 with an indication of fracture spreading - yellow arrow

Fracture areas of the tooth 1 in area of Fragment A show a conchoidal relief with signs of gradual spread of the fatigue fracture from surface of the active tooth in the tooth engagement (in direction of the force acting) in area of the foot ring and then also down towards to the axis of the wheel. This characteristic of the fracture area is identical to

a characteristic of the fracture area in the area B of the tooth 2

Other parts of fracture of tooth 1 and tooth 2 correspond to the brittle fracture characteristics (grain, rough and rugged surface with clear microstructure of the material, with no marks and deformations)

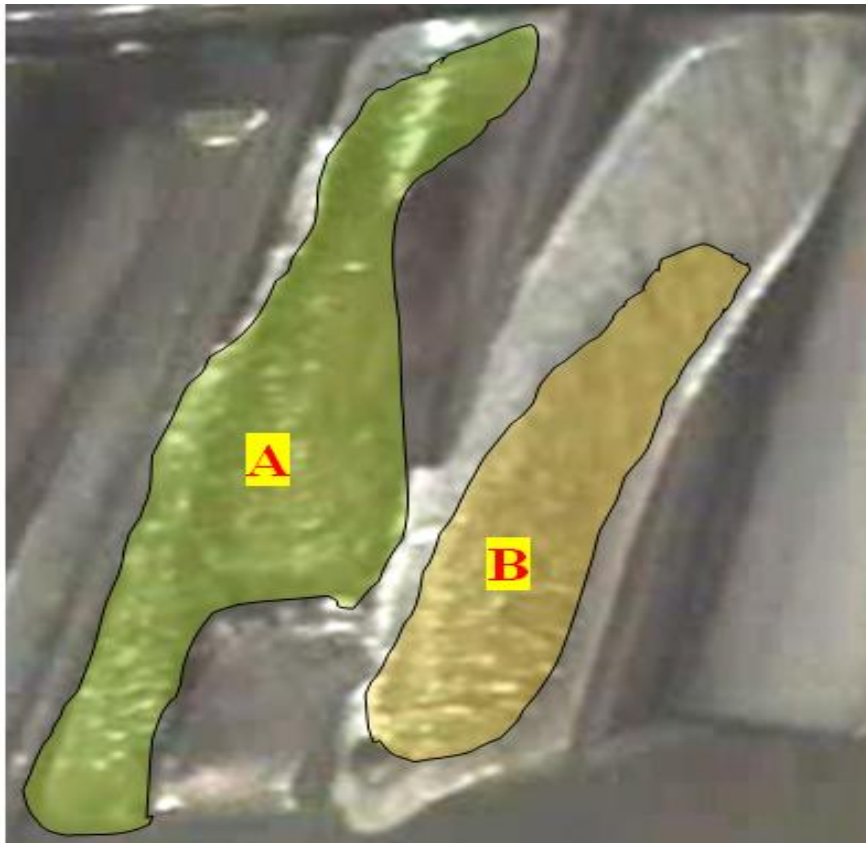
Obr.6 View of characteristics of teeth fracture areas P2 (A), P1 (B)

- 1<sup>st</sup> stage: occurrence of fatigue fracture on tooth no.1 at fracture area A (P1)  
Mentioned fatigue fracture with its characteristic of the fracture surface gives with the number of fatigue and relaxation lines assumption that its formation took place over a longer period of time, that it originated with plastic deformations in the fracture area and from the direction of line it is possible to derive its propagation direction (as shown) and the fracture area does not cross the engagement line.

- 2<sup>nd</sup> stage: formation of brittle fracture on the tooth No. 1 outside of area A (P1)  
After a time when the fatigue fracture propagation process in area A reached the limit of strength of the remaining tooth material, a brittle fracture of this material occurred (fracture of tooth out of the engagement line)

- 3<sup>rd</sup> stage: : formation of brittle fracture on the tooth No. 2 in area B (P2)  
Listed fatigue fracture with its characteristic of the fracture surface gives with the number of fatigue and relaxation lines assumption that its formation took place over a shorter period of time than the fatigue fracture on tooth No. 1 in the region A that its propagation direction is the same as the propagation direction of fracture in region A, the area of the fracture does not cross the engagement line.

- 4<sup>th</sup> stage: formation of brittle fracture on the tooth No. 2 outside of area B (P2)  
After a time when the fatigue fracture propagation process in area B reached the limit of strength of the remaining tooth material, a brittle fracture of this material occurred (fracture of tooth out of the engagement line)

On the basis of the known facts and the findings made, technical expert has concluded that the detected failure of Volvo FH 12 4x2 T 380 TN trailer gearbox was caused by fatigue fracture (P1 - area A) on the tooth (1) of the countershaft, resulting in the teeth 1 (P1 – outside of area A) being broken off with brittle fracture, during which the fatigue (P2-area B) on the second tooth of the shaft (tooth 2), due to which the tooth 2 (P2 - outside area B) was broken off with brittle fracture, and it is most likely that in time after the tooth 1 breaks there have been D1, D2, D3 fractures on the teeth of engagement gear wheel on the spline shaft.
