Investigation of Pedestrian Safety - A Case Study

Getu Tamiru" Investigation of Pedestrian Safety - A Case Study" International Journal of Engineering Inventions, Vol. 07, No. 10, 2018, pp. 35-45

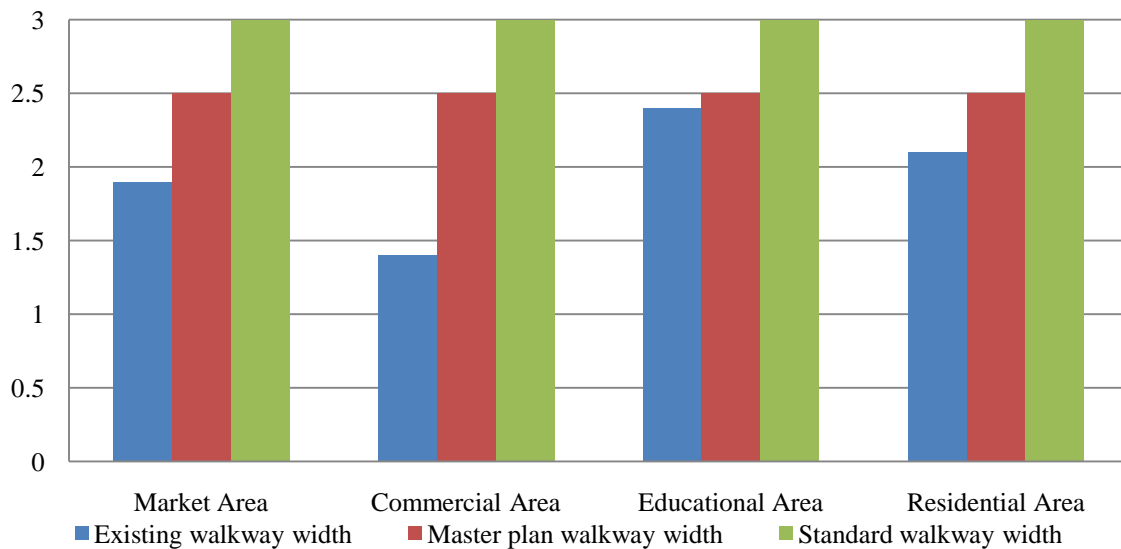
Fig. 1 Comparison of Existing, Master Plan and Standard Walkway Width

Pedestrian volumes were relevant to traffic and highway engineering practice. Also, other pedestrian volume influences the geometric features such as pedestrian over and under passes, elevated walkways, and crosswalks. Walking characteristics play a major part in the geometric design features and some of the controls devices. As I compare the walkway roadsides in the studied area with the standard highway capacity manual, they do not satisfy the criteria which indicate the sidewalk width need upgrading to accommodate the peak pedestrian volume.

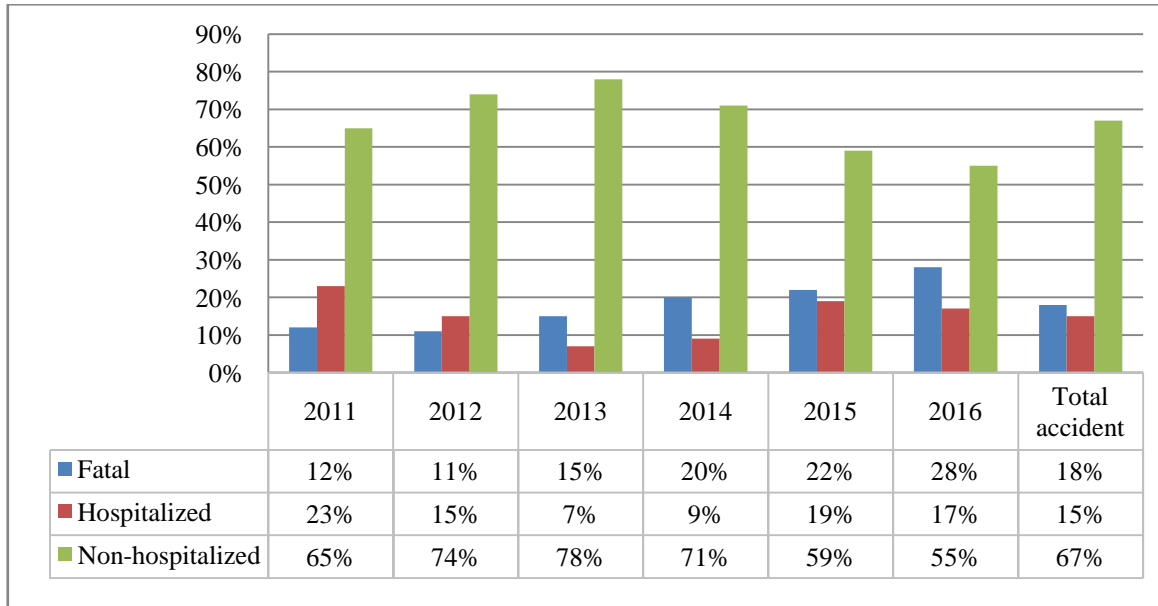
Fig. 2 Pedestrian Accident Severity in Mizan city (2011 - 2016)

In Mizan city about 210 traffic accidents were recorded in the last six years and in this, more than 20% of pedestrians have resulted in death. The report indicates that majority of the casualties were located away from a pedestrian crossing, at the non-designated midblock crosswalk, when they cross a road and share the carriageway for walking purposes. When they were asked about why they do not use safer means crossing on a zebra, they replied that the crossing facilities are not provided at a logical distant and are preferable on crossing the road directly is quicker. Analysis of pedestrian road crossing behavior showed that 47% of pedestrians use crosswalks correctly while 53% of pedestrians cross at non-designated locations. As the study indicates on all segments the available type of facility is a zebra, but it is not visible even for pedestrians on many places and needs maintenance which is functional in all seasons.

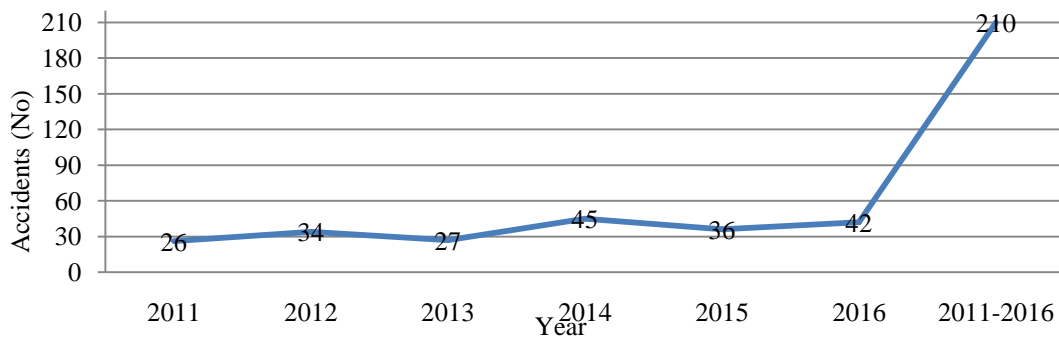
Fig. 3 Pedestrian Accident Trends in Mizan city (2011 - 2016)

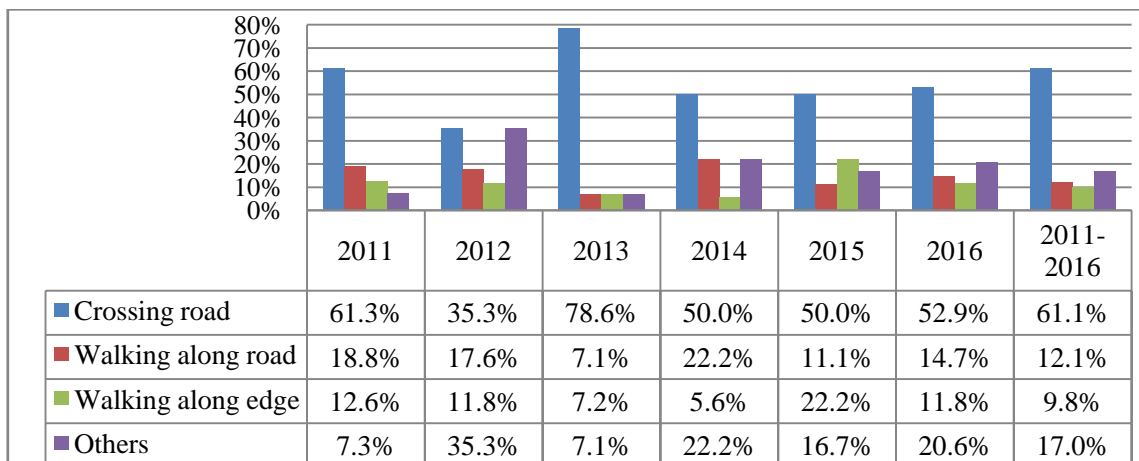
Fig. Error! No text of specified style in document. Pedestrian Behavior and Casualty Location in Mizan city (2011-2016)

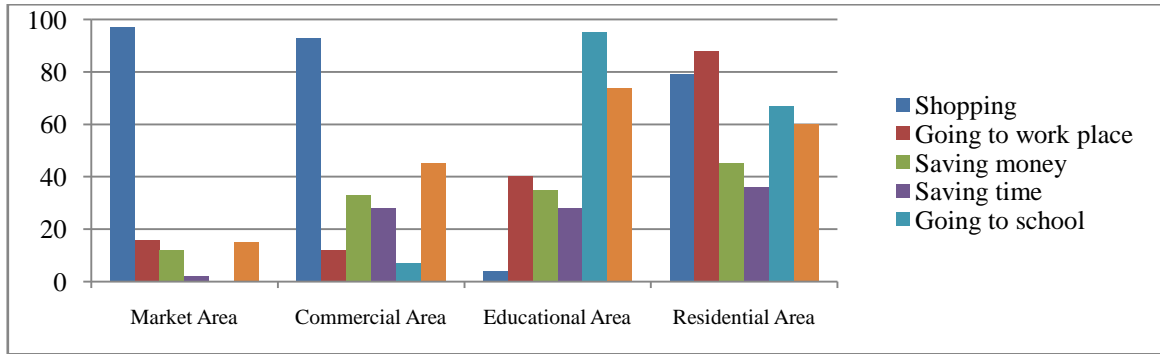
Fig. 5 Pedestrians Purpose of Walking in Mizan City (source: Field survey)

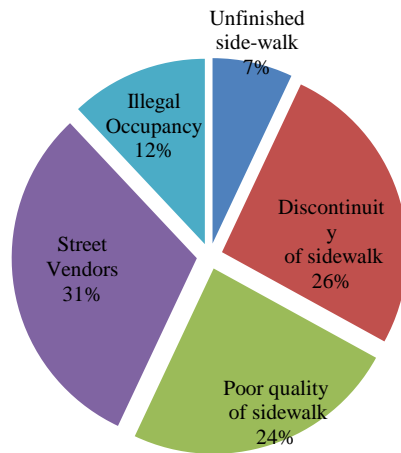
Fig. 6 Reasons for not preferring the sidewalk
