Analysis of Flexible Pavement Distresses

A Case Study of Kandahar- Spin Boldak Highway in Afghanistan

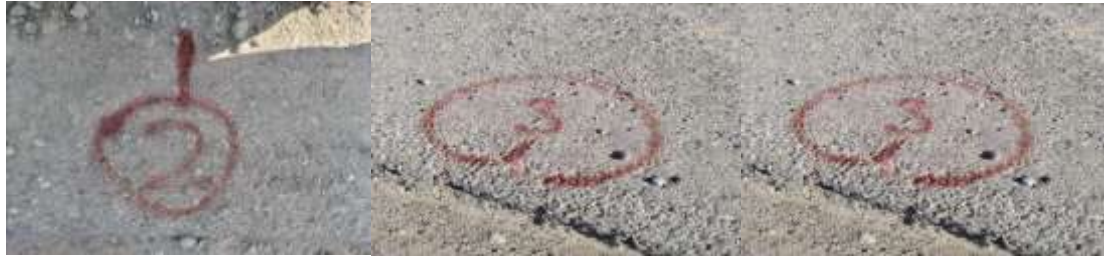
- **Step 2:** divide that branch into three sections (A, B, C). The length of each section is 3.3 km.
- **Step 3:** we decide on the pavement sections dividing them into smaller sample units. The standard size for asphalt pavement samples from the (ASTM-D6433) sample unit is (255 ± 95) . The Kandahar Spin-Boldak old highway width is 7m. So, we took the length sample of 35m. So, the total area of the sample is equal to 245m²; then, the number of samples present in the section will be determined from the following equation.

$$(1) \quad N = \frac{\text{Length of the section}}{\text{Length of the sample}} = \frac{3300m}{35m} = 95 \text{ samples}$$
