## Procedure for Technical Analysis of the Cause of Volvo FH 12 Road-Train Trailer Gearbox Failure

Ján Mandelík<sup>1</sup>

<sup>1</sup>Department of Transport Safety, The University of Security Management in Kosice, Kosice, Slovak Republic  
Corresponding Author: Ján Mandelík

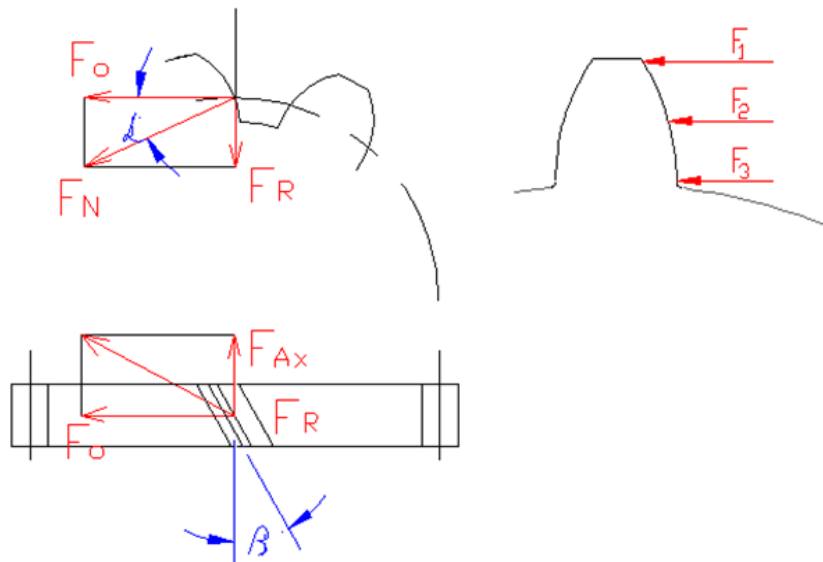
**Fig.3 showing forces acting in gearbox gearing**

Fig.3 shows forces acting in gearbox gearing

Note: The position of load changes during engagement. At the beginning of engagement, the load acts on head ring ( $F_1$ ) and ends up on foot ( $F_3$ ) see fig.3.
